Ellsworth Public Library

Building Assessment Report

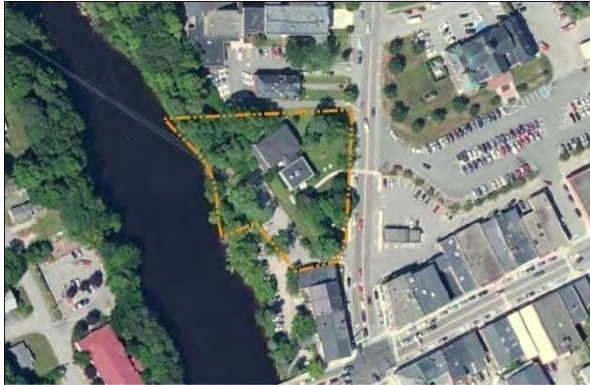
Aerial View of the Library & Grounds

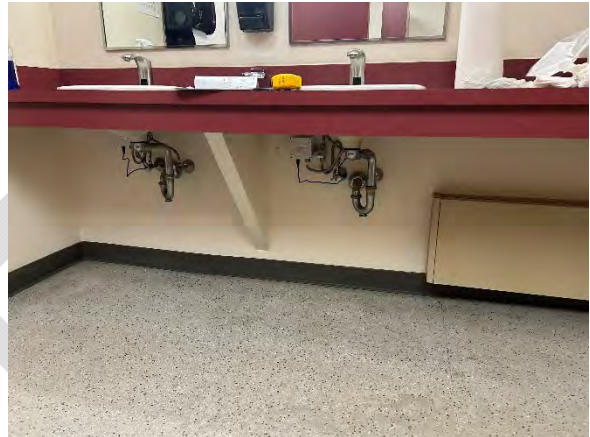
Exposed Sink Pipes at the New Addition

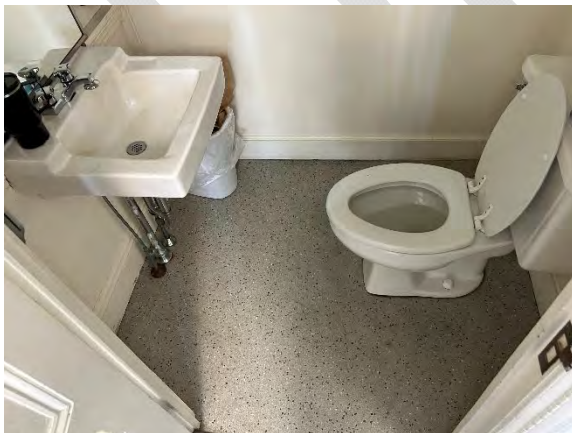
First Water Closet at the Tisdale House

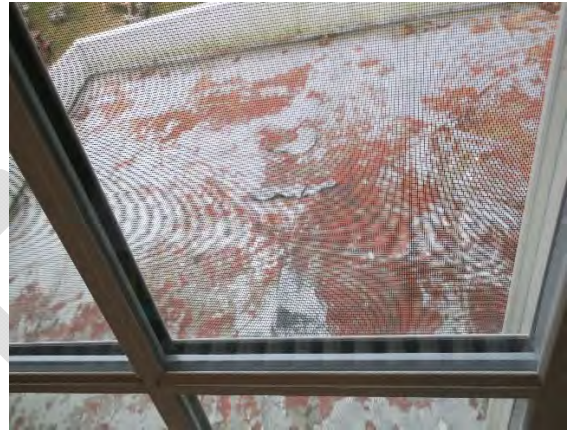
Tin Roof at the Tisdale House Entry

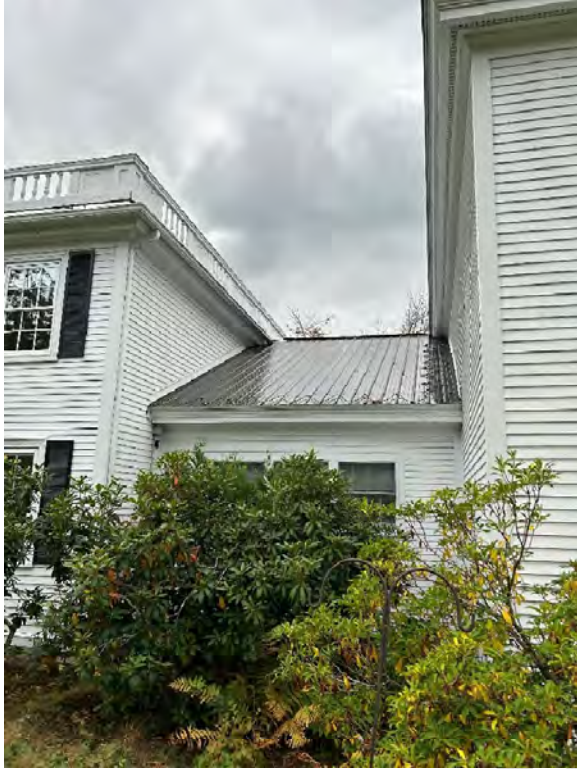
Standing Seam Roof at the Connector

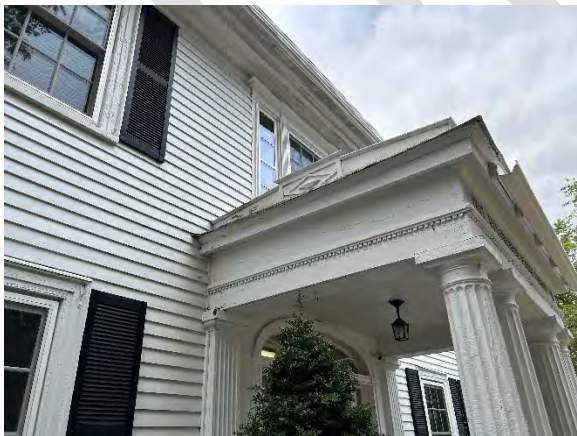
Siding & Trim at the Tisdale House

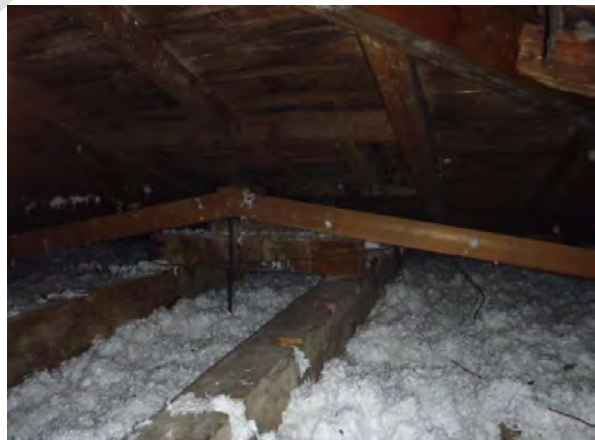
Attic Insulation at the Tisdale House

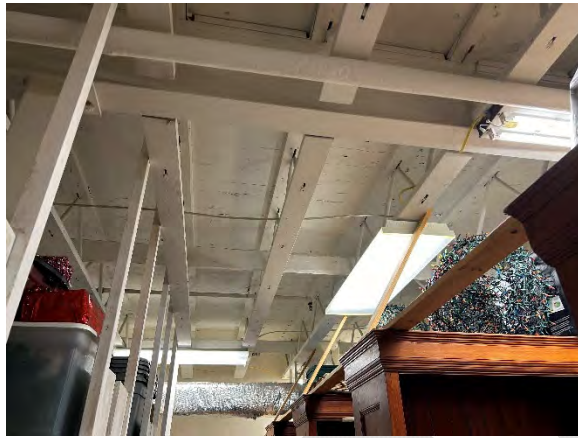
First Floor Framing at the New Addition

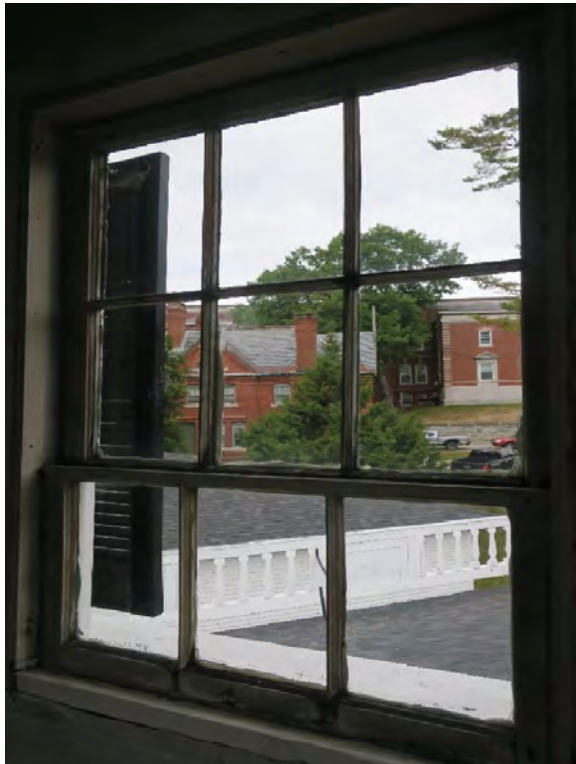
*Single-Pane Window at the Cupola
Showing a combination of old and new windows*

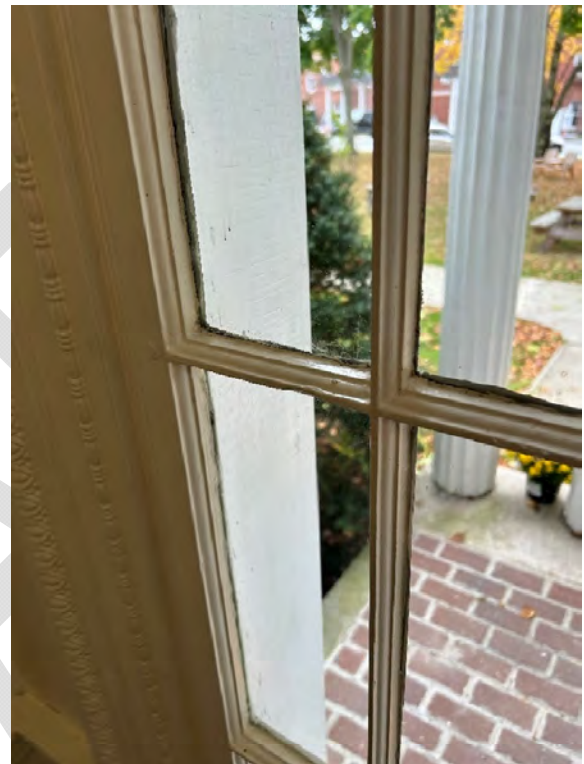
Single-Pane Sidelight at the Entry Door

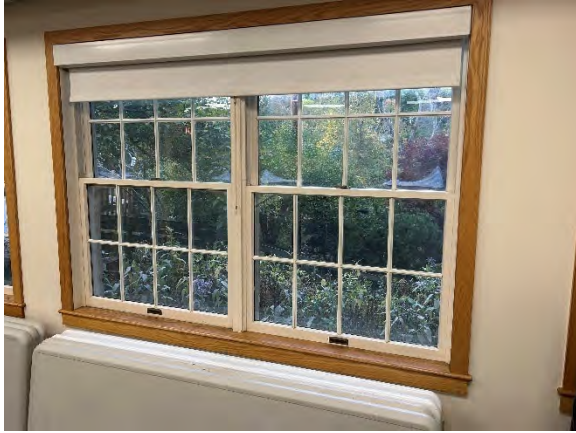
Fogged Glass at the New Addition

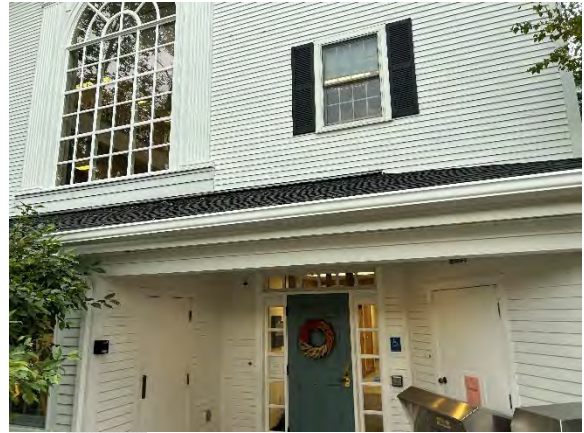
Windows & Doors at the New Addition

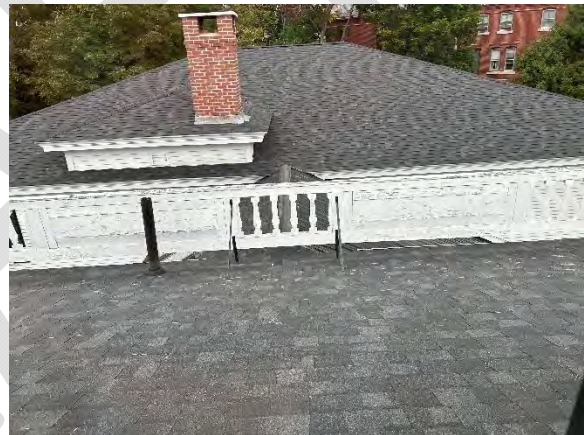
Chimney & Penthouse at the New Addition

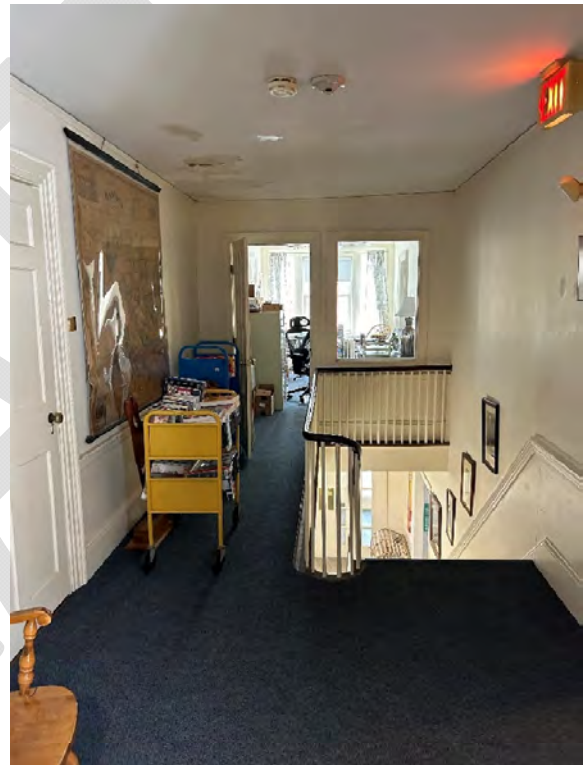
Second Floor Hall at the Tisdale House

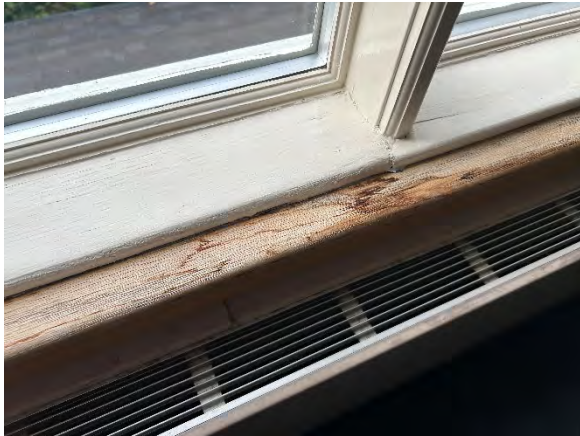
Water-Stained Sill at the New Addition

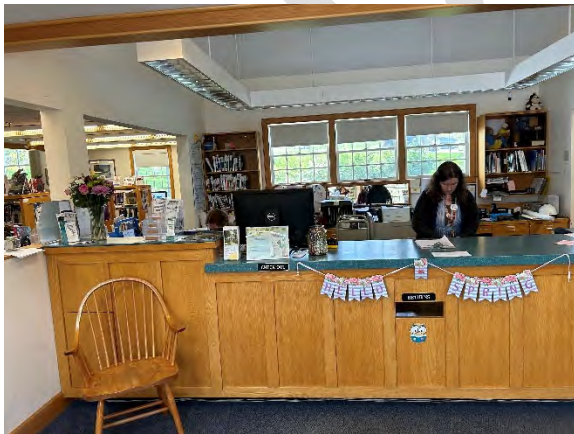
Circulation Desk at the Connector

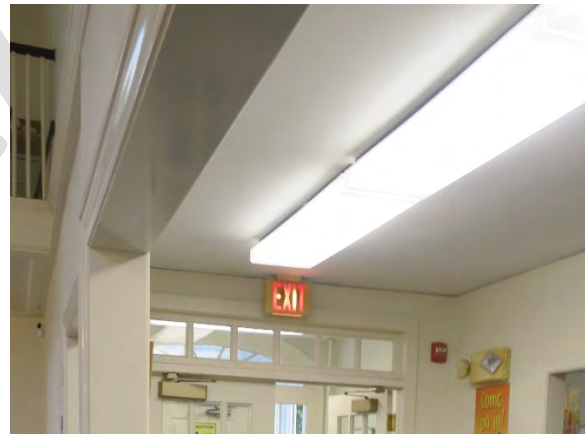
First Floor Hall Lighting at the Tisdale House

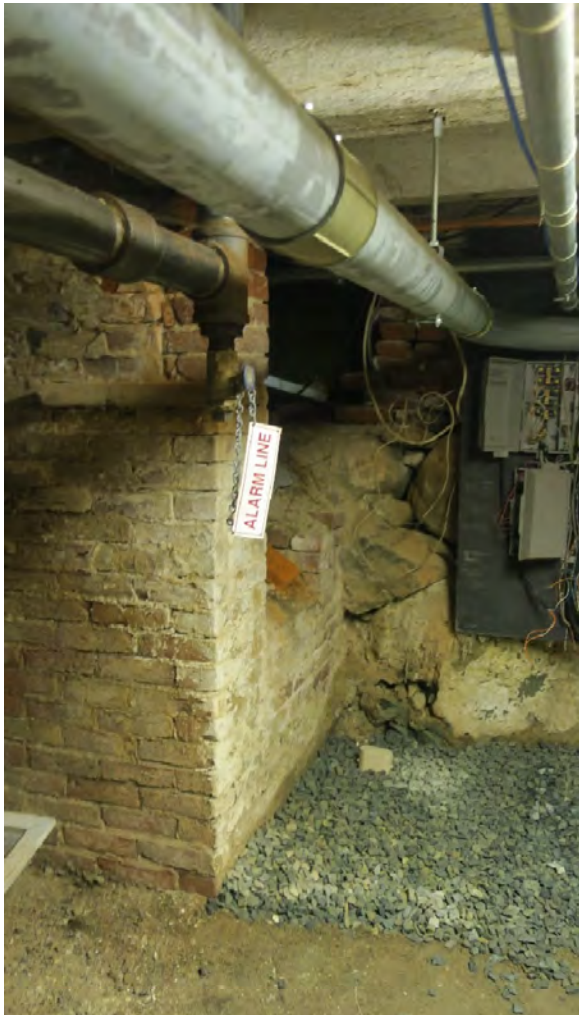
Dirt Basement Floor at the Tisdale House

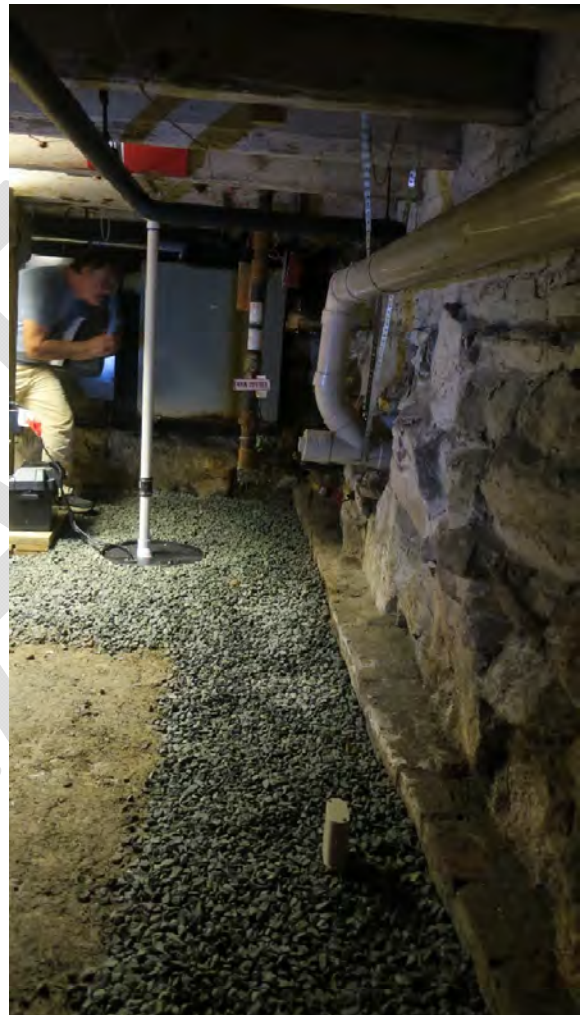
SE Sump Pump at the Tisdale House

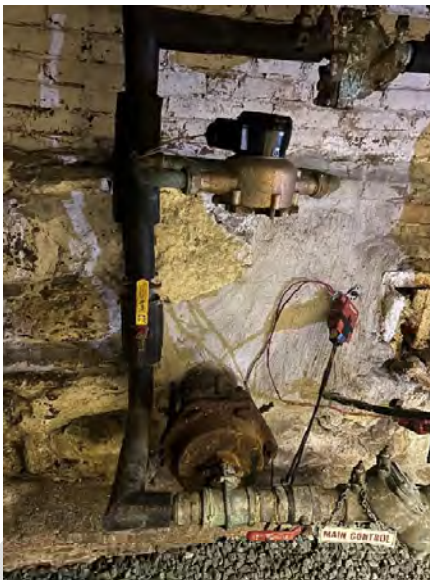
Domestic Water Service

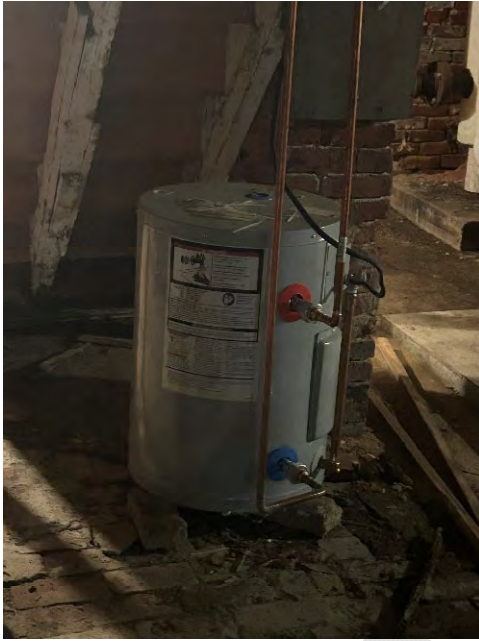
Electric Water Heater

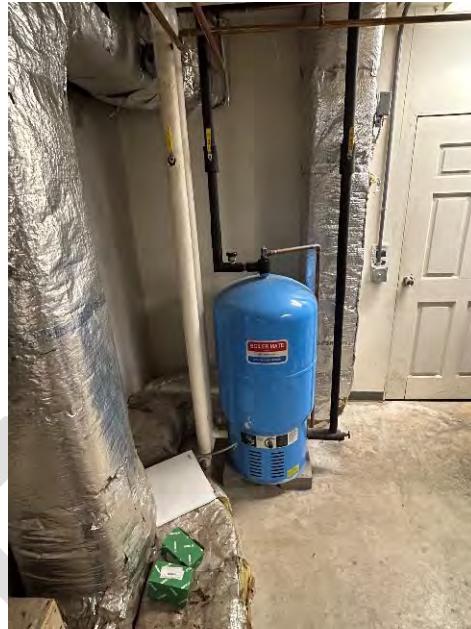
Existing Boiler Mate

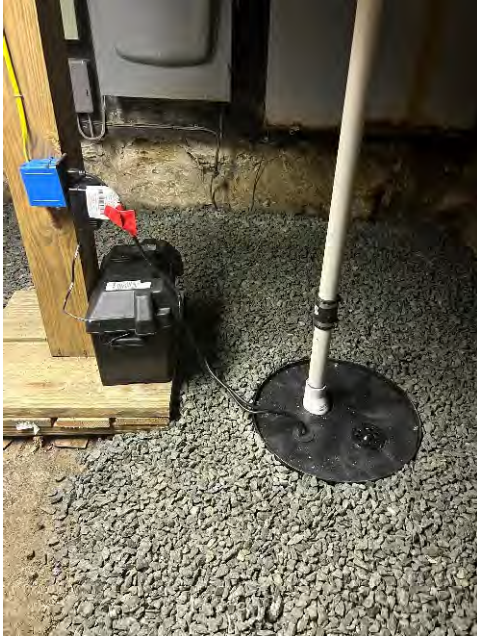
Two sump pump stations with battery backup are provided in the Tisdale House basement to collect ground water/rain water that migrates thru this area from the floor and stone foundation wall. Sump pumps were recently installed, and operation has been working well.

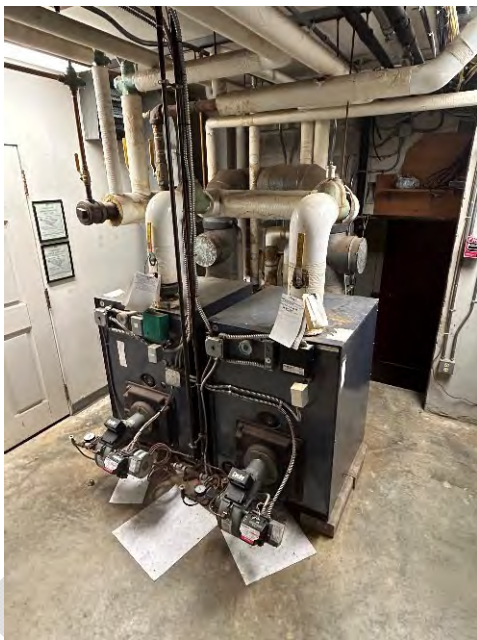
The boiler plant consists of two Weil McLain BL576 cast iron sectional boilers that appear to be in good condition. The burners are oil fired Carlin Burners that are currently running properly. The boilers can remain in service at this time, but consideration for replacement of boilers should be in the next 5 – 10 years.

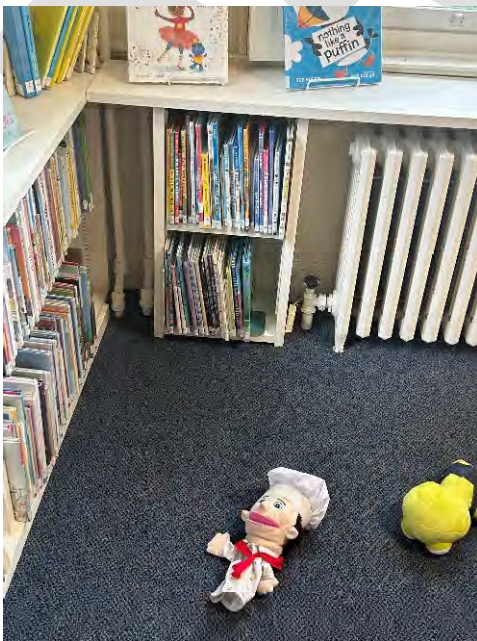
- A. Recommend installing a ceiling mounted hot water unit heater in the lower-level storage room. Heater shall be tied to boiler plant. Provide programmable wall thermostat to cycle unit heater as required during occupied periods of library.

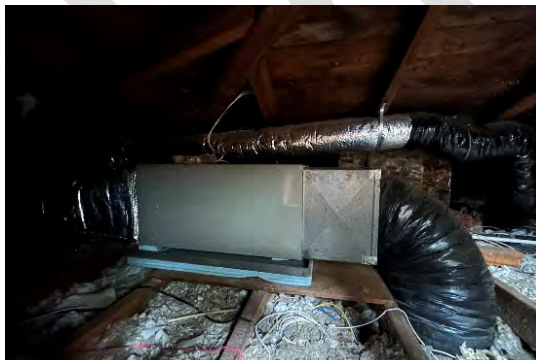
The ductwork distribution system serving these three air handlers should be cleaned to improve indoor air quality conditions associated with ductwork distribution system. Periodic duct cleaning is recommended every 5 – 10 years and it is assumed this ductwork has not been cleaned since installation.

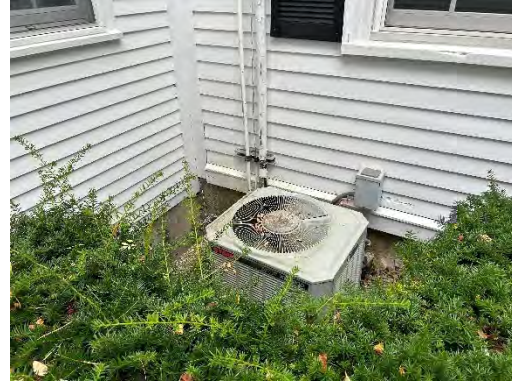
Central Condensing Unit

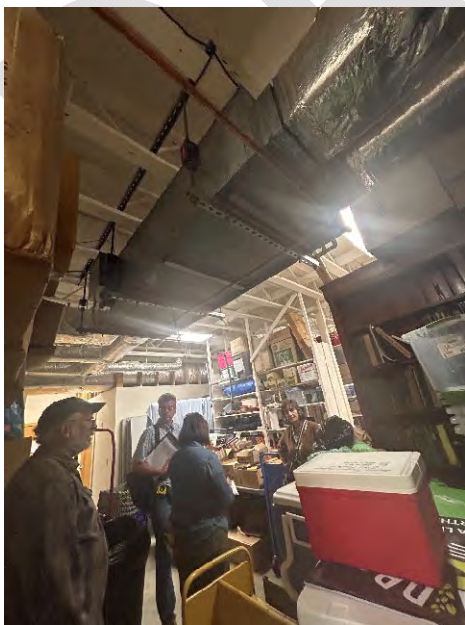
The breakroom located on the lower level is provided with a ducted range hood without a fire suppression system. If kitchen range is not used often, consider removing range and the associated fire risk associated with ranges in public spaces. Otherwise, a new range hood with integral fire suppression is recommended.

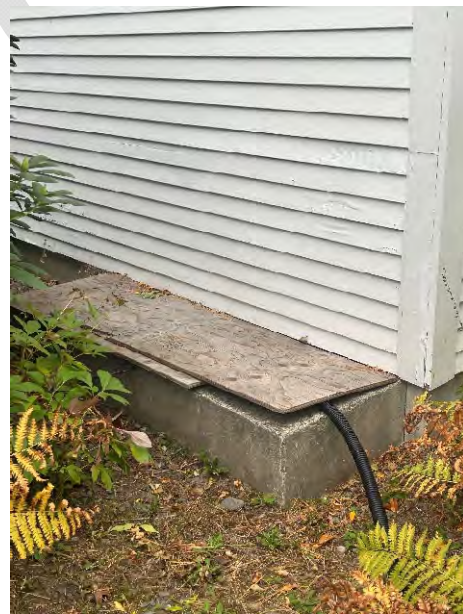
Exterior Window Well

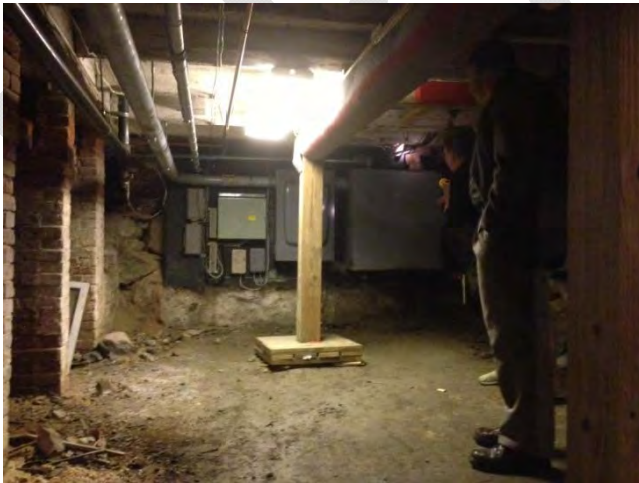
The Tisdale House basement consists of stone walls and concrete walls. The basement floor in this area also consists of exposed ledge, dirt floors, crushed stone, and concrete floors in poor condition. This area is susceptible to allowing Radon to migrate into the building and into the occupied spaces thru natural air movement or potentially thru the air handler located in the basement. Consideration to improve air/vapor migration from below grade into building should be addressed thru waterproofing basement floor/foundation walls. In addition to providing this waterproofing membrane system, consideration for radon testing and installation of provisions of radon mitigation and testing should be addressed. Testing in lower-level addition space should also be performed for this side of building.

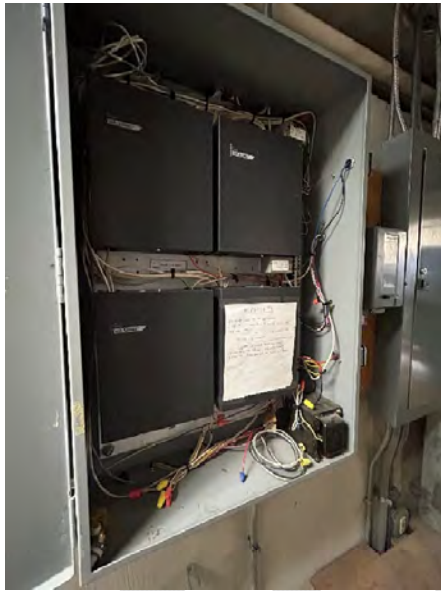
Existing Control Panel

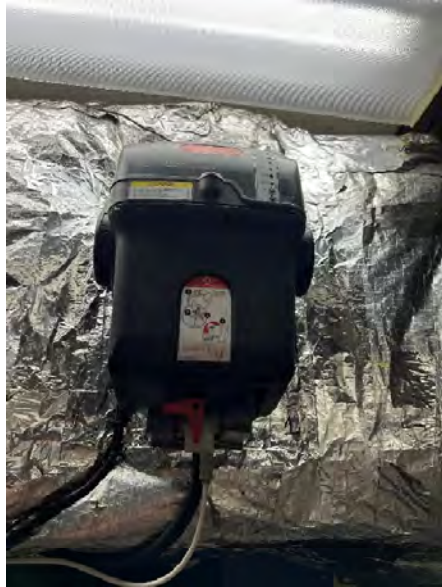
- A. Recommend replacing the existing Honeywell Steam Humidifier with a light commercial grade and capacity. Replacement should include new water filters and associated solenoid valves, space humidity sensor (located in the Genealogy Area on second floor).

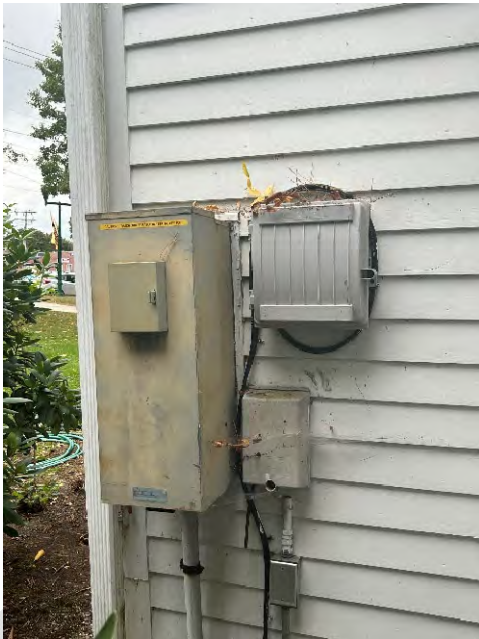
Exterior Electric Service

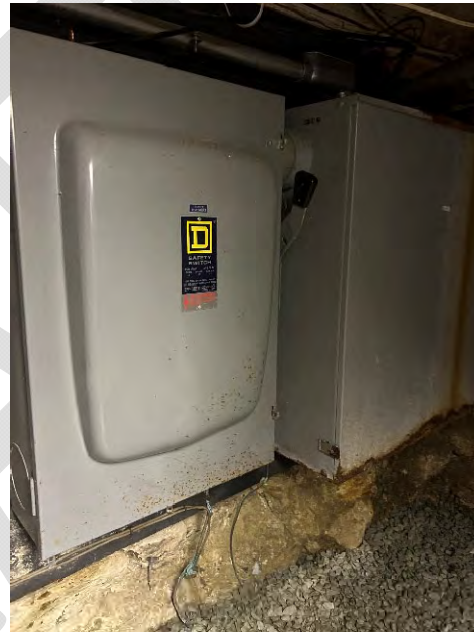
Interior Electric Panels

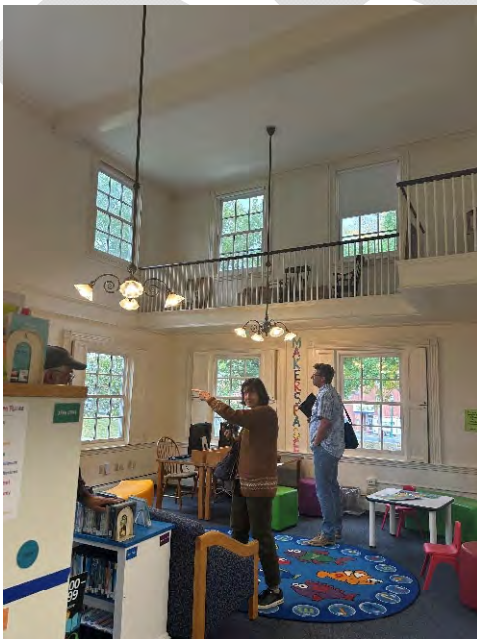
Children's Room – Tisdale

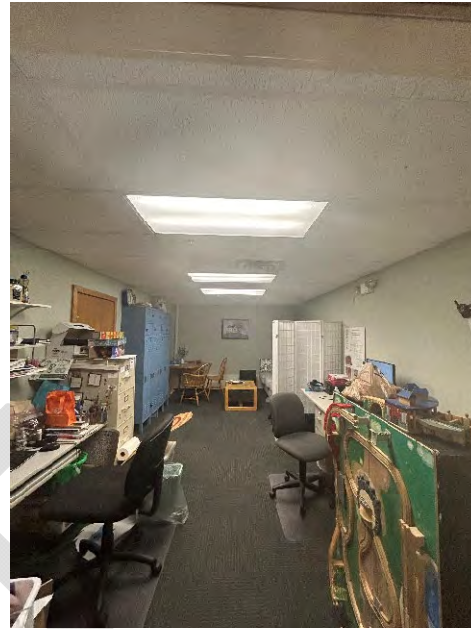
Staff Lounge / Storage Area

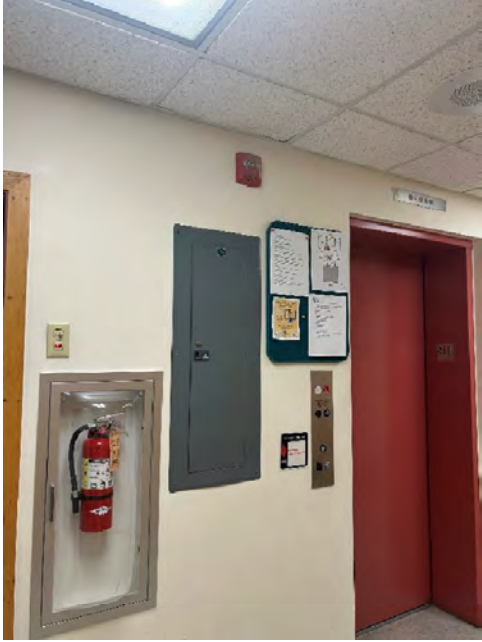
The fire Alarm System is provided throughout the facility and appears in good condition. The fire alarm panel is Notifier NFW2-100 and is currently maintained by Norris Incorporated. Fire alarm system consists of manual pull stations, smoke detectors, heat detectors, audio/visual devices, and supervision of the sprinkler system.

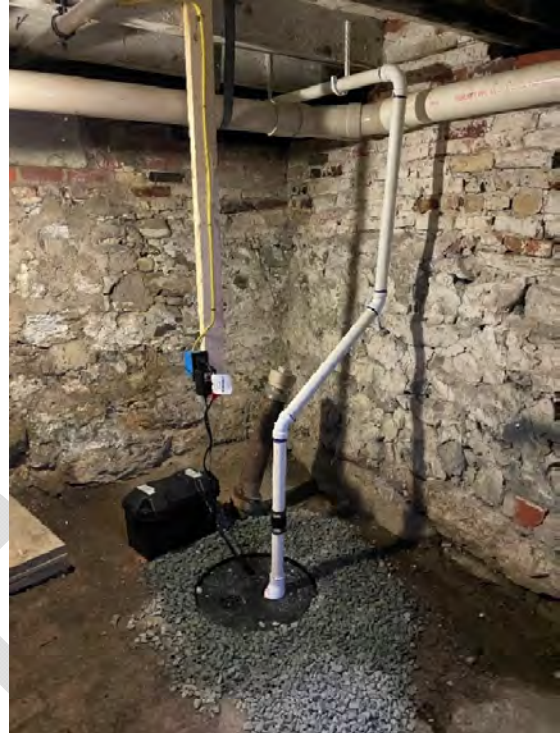
Photo 2 – grouted stone and brick foundation walls, sump pump system

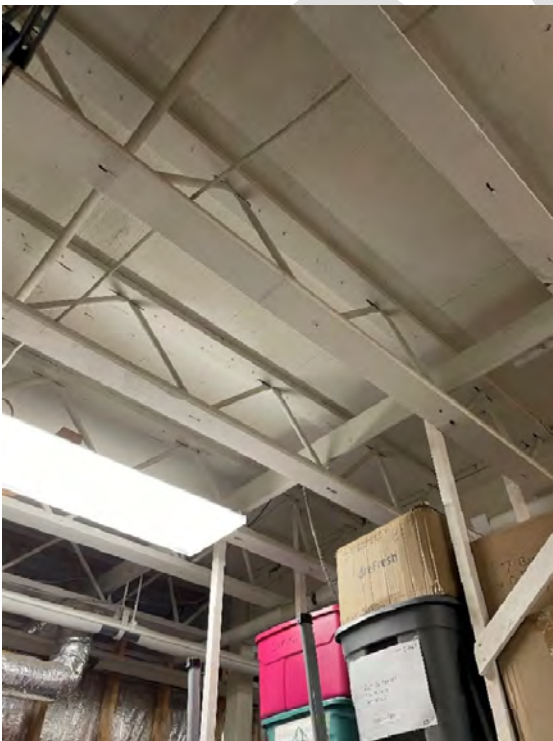
Photo 3 – First floor framing in addition, from lower level

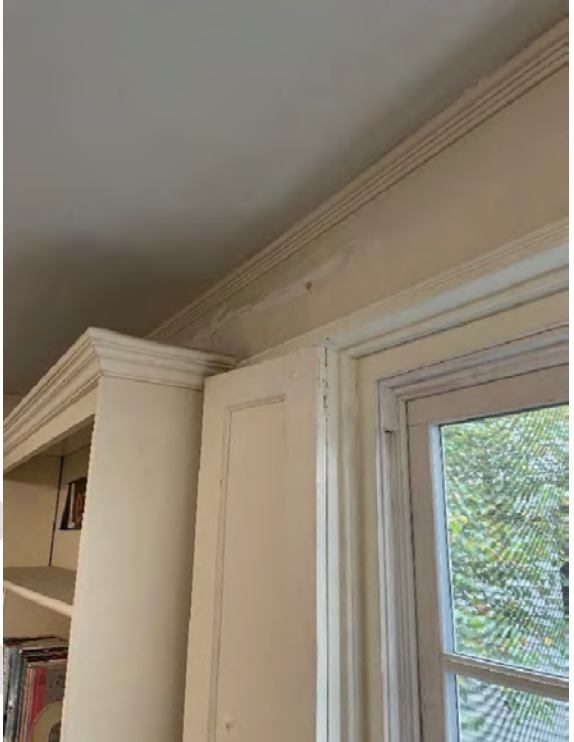
Photo 6 – Plaster crack and repair on first floor, Tisdale House

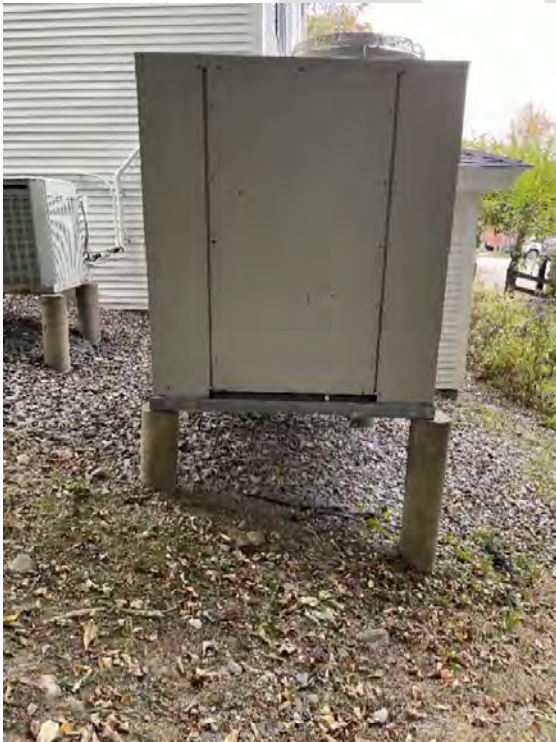
Photo 7 – Tilting sonotube HVAC supports (see mechanical section)

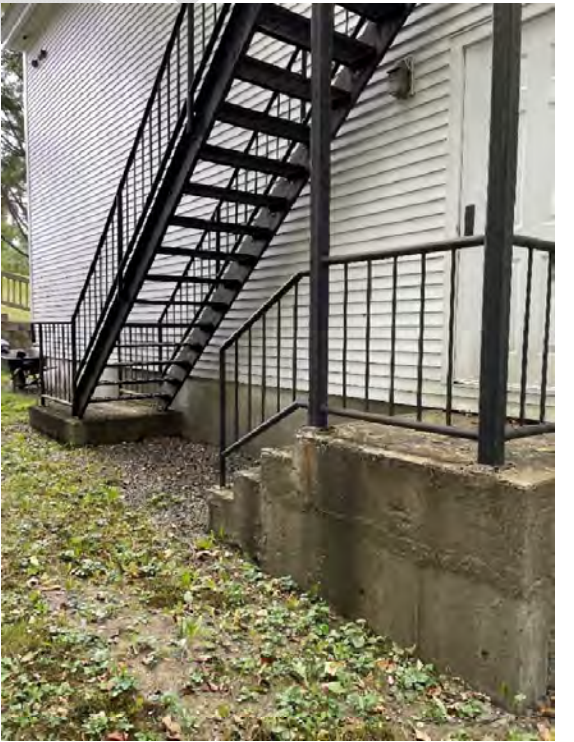
Photo 8 – Addition fire escape foundations

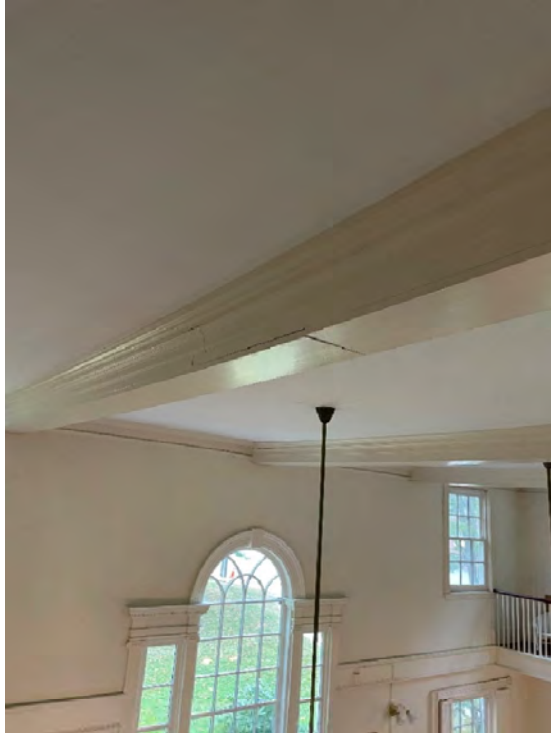
Photo 15 – Original ceiling, cracked trim

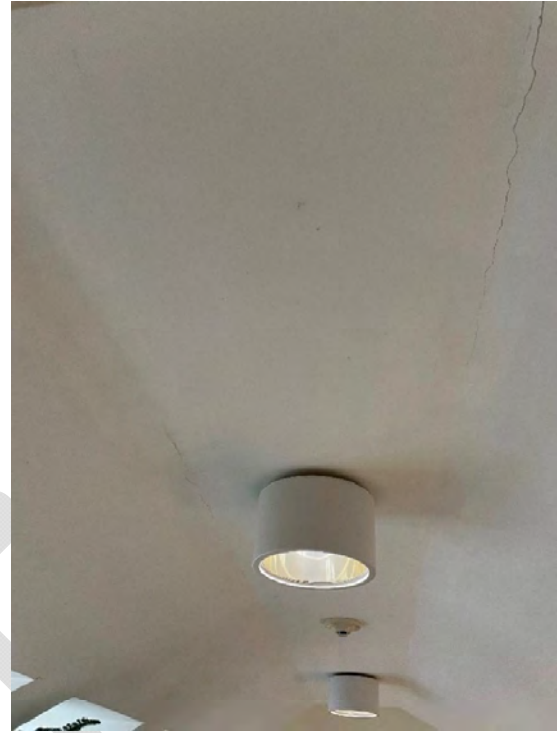
Photo 16 – Connector to addition, drywall cracks in ceiling

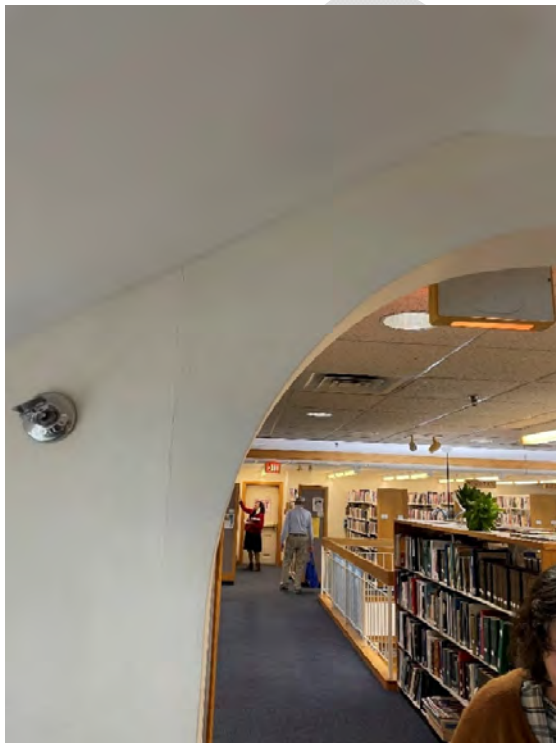
Photo 17 – Connector to addition, drywall cracks

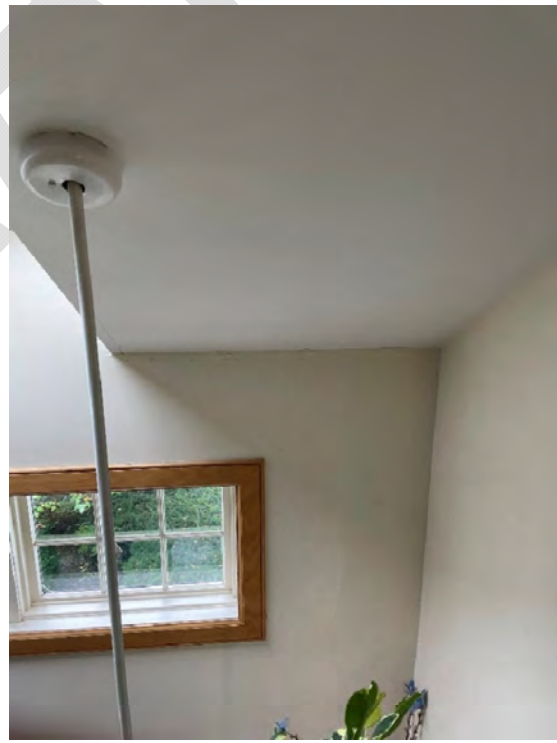
Photo 18 – Connector to addition, drywall cracks, cracked window pane (lower left)

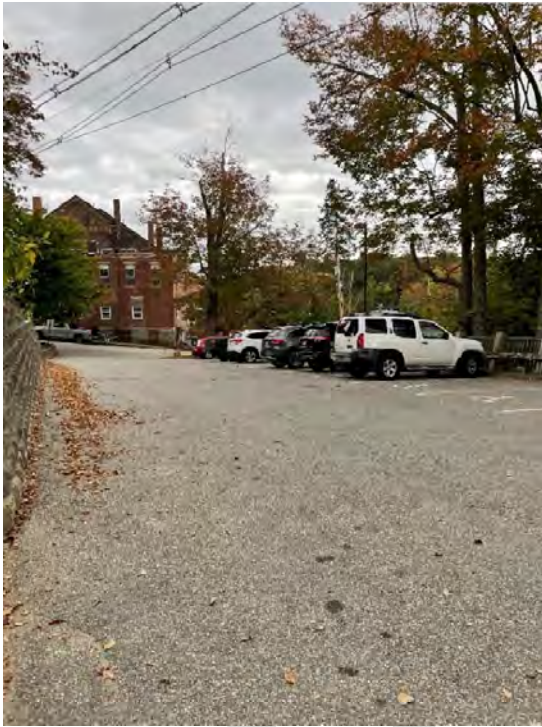
Photo 1 – Lower parking lot

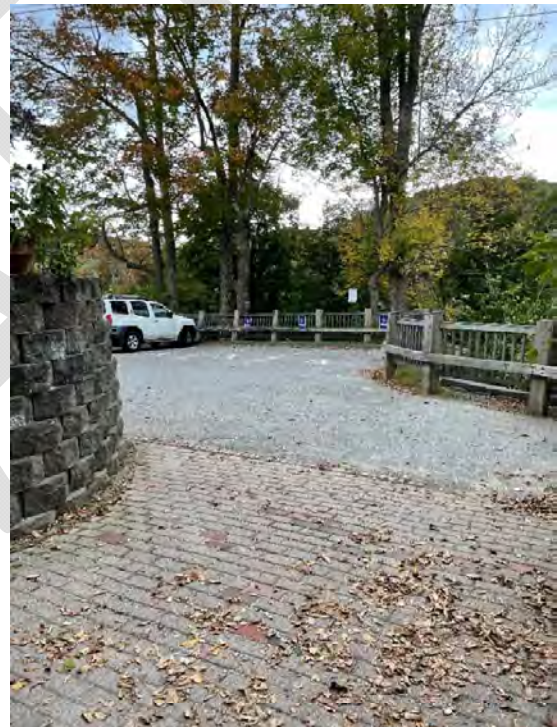
Photo 2 – ADA parking spaces, missing loading zone

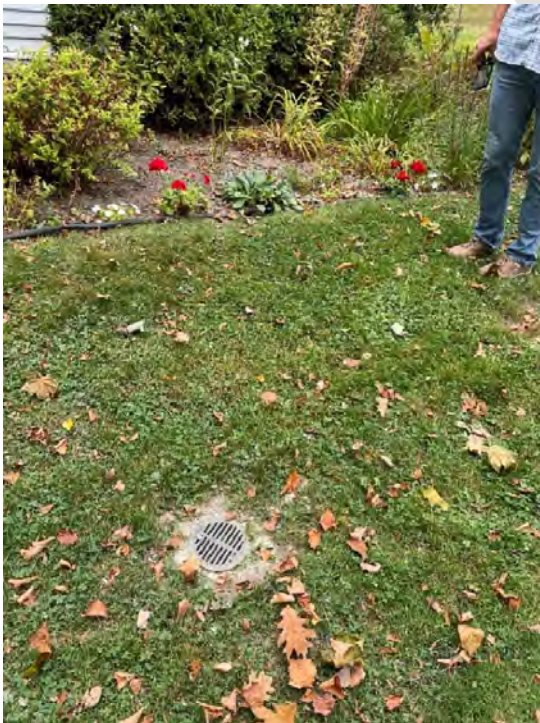
Photo 9 – Drain basin near upper main entrance

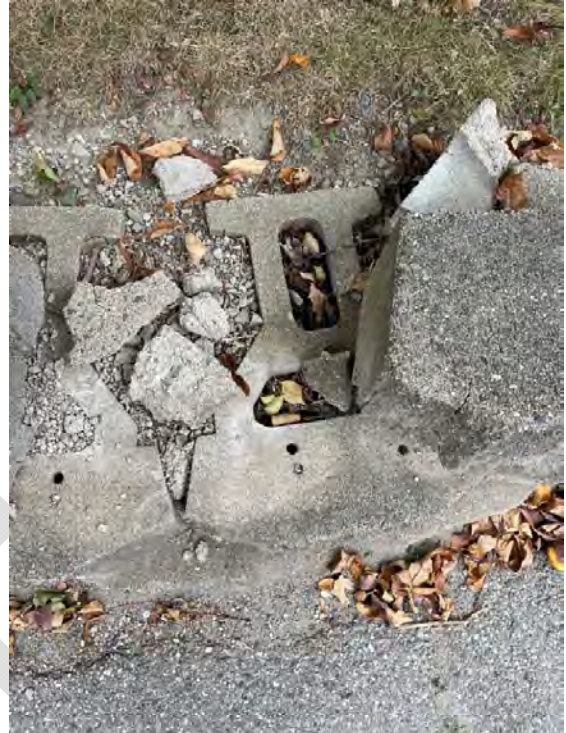
Photo 22 – Close up of deteriorated block caps

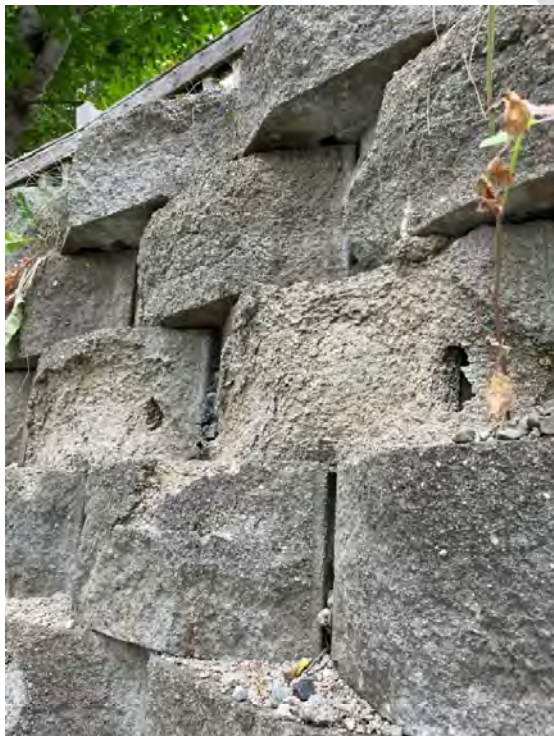
Photo 23 – Close up of deteriorated block facing

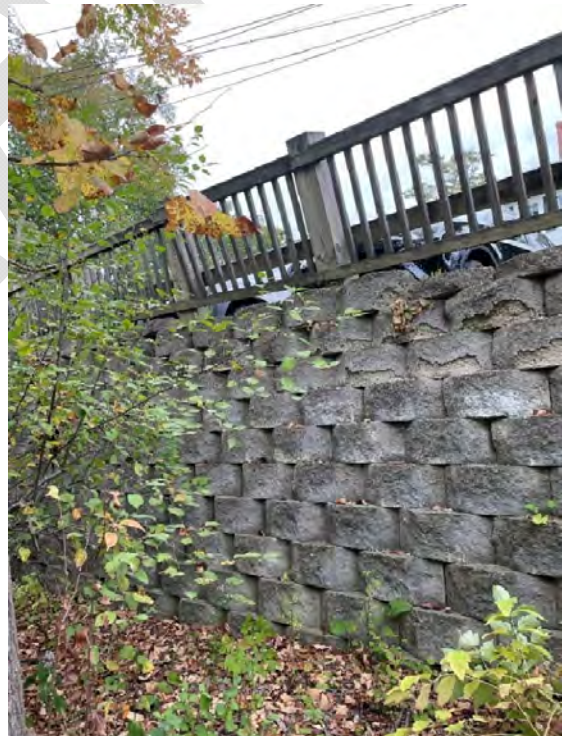
Photo 24 – Retaining, west side of parking lot
